Home Inspection Report

14 Anywhere Ct
Lutherville-Timonium, MD 21093

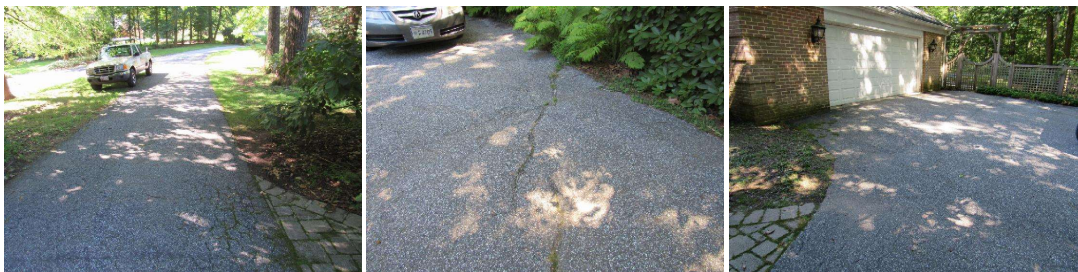
Driveway: Asphalt - Damaged or deteriorated, recommend estimate for repair or replacement by a licensed contractor

1. Driveway: Asphalt - Damaged or deteriorated, recommend estimate for repair or replacement by a licensed contractor
2. Cupolas: wood - paint damage, suggest further evaluation and repair as needed. Does not appear to be functional.
3. Vegetation: Tree limbs over hang the roof and should be cut back, no plants should be allowed to grow on the building. plants are growing into window wells. Have corrected by a qualified contractor.
4. Grading/Swale Flat, Minor slope - Ideally the grading should slope about 6 inches over the first 10 feet away from the house foundation. Recommend observing during a heavy rain to ensure no water is sitting against foundation.
5. Fascia/soffit Wood - Paint is peeling in many spots. Section of what appears to be carpenter bee damage. Have repaired by qualified contractor.

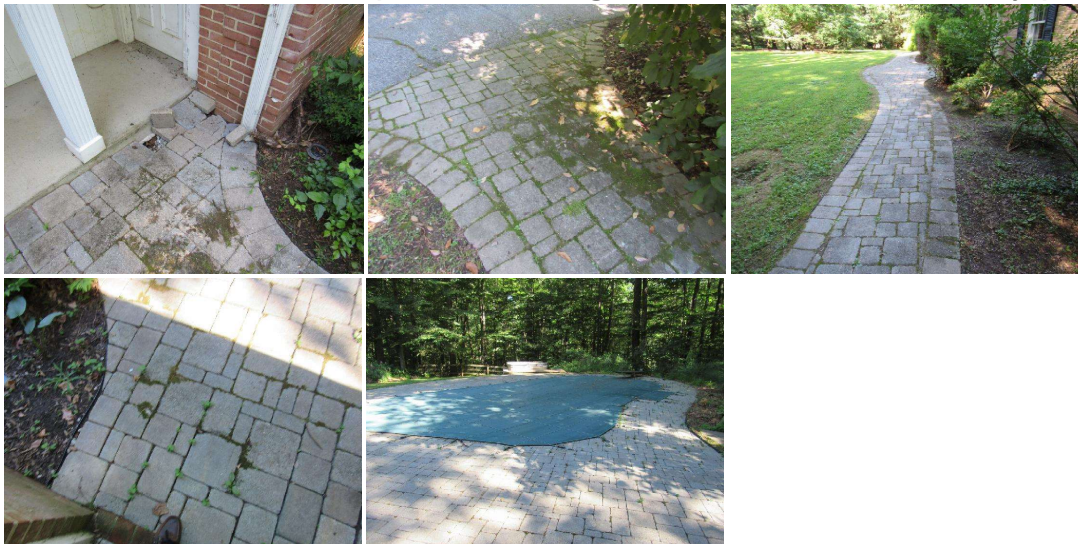
Walks: Paver - settlement, trip hazards, moss growth observed. Have repaired by qualified contractor.

1. Walks: Paver - settlement, trip hazards, moss growth observed. Have repaired by qualified contractor.
2. Basement Stairwell: Concrete - Area should be cleared of debris and dirt, ensure drain is functioning. Missing handrail. moss growth on stairs and walls should be removed. Re Point brick as necessary. no drainage observed.

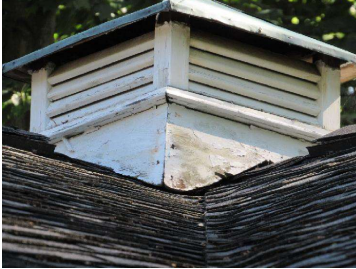
Marginal Cupolas: wood - paint damage, suggest further evaluation and repair as needed. Does not appear to be functional.

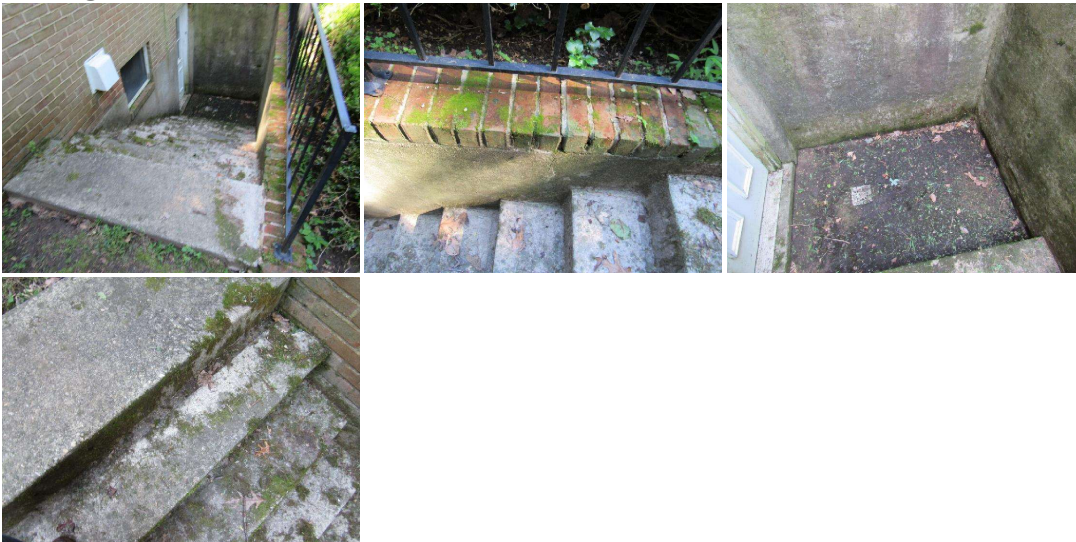
Defective Basement Stairwell: Concrete - Area should be cleared of debris and dirt, ensure drain is functioning. Missing handrail. moss growth on stairs and walls should be removed. Re Point brick as necessary. no drainage observed.

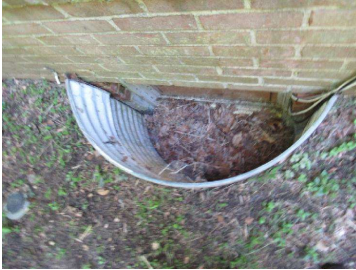
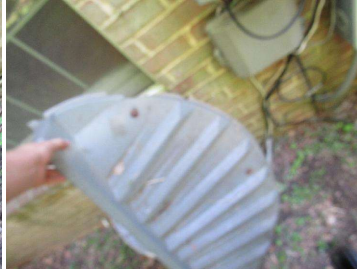
Window Wells: (continued)

Defective Window Wells: Drain Not visible - Could not inspect due to build up of debris, Cover is cracked or damaged. Have cleaned out, covers replaced. If drain is present ensure they are operational. Have further evaluated and repaired by a qualified contractor.

3. Window Wells: Drain Not visible - Could not inspect due to build up of debris, Cover is cracked or damaged. Have cleaned out, covers replaced. If drain is present ensure they are operational. Have further evaluated and repaired by a qualified contractor.

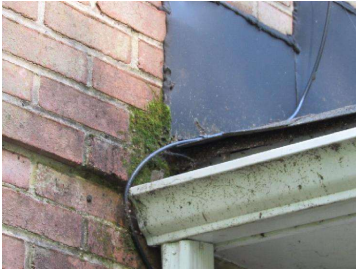
Acceptable Type: Brick veneer - moss growth and vegetation should be removed.

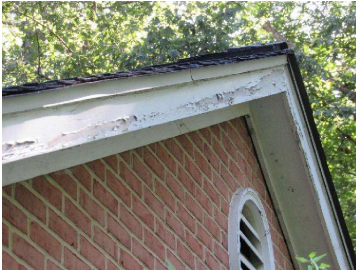
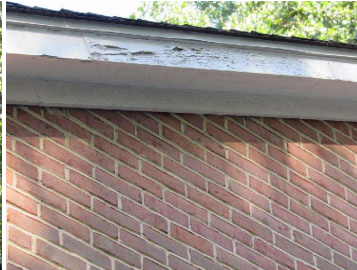
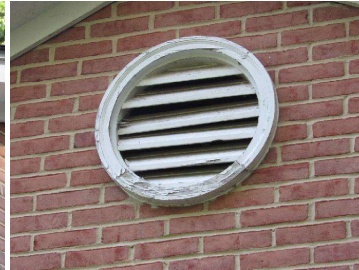
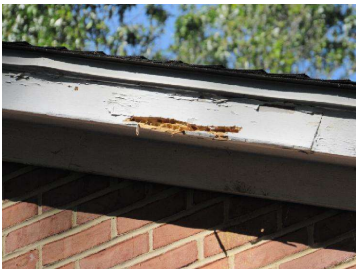
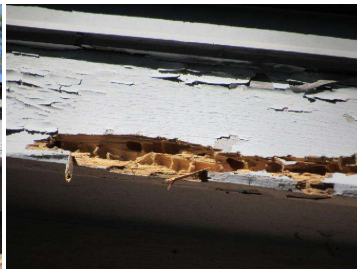
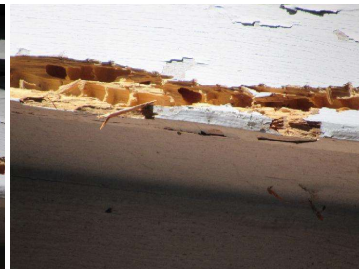
Marginal Fascia/soffit Wood - Paint is peeling in many spots. Section of what appears to be carpenter bee damage. Have repaired by qualified contractor.

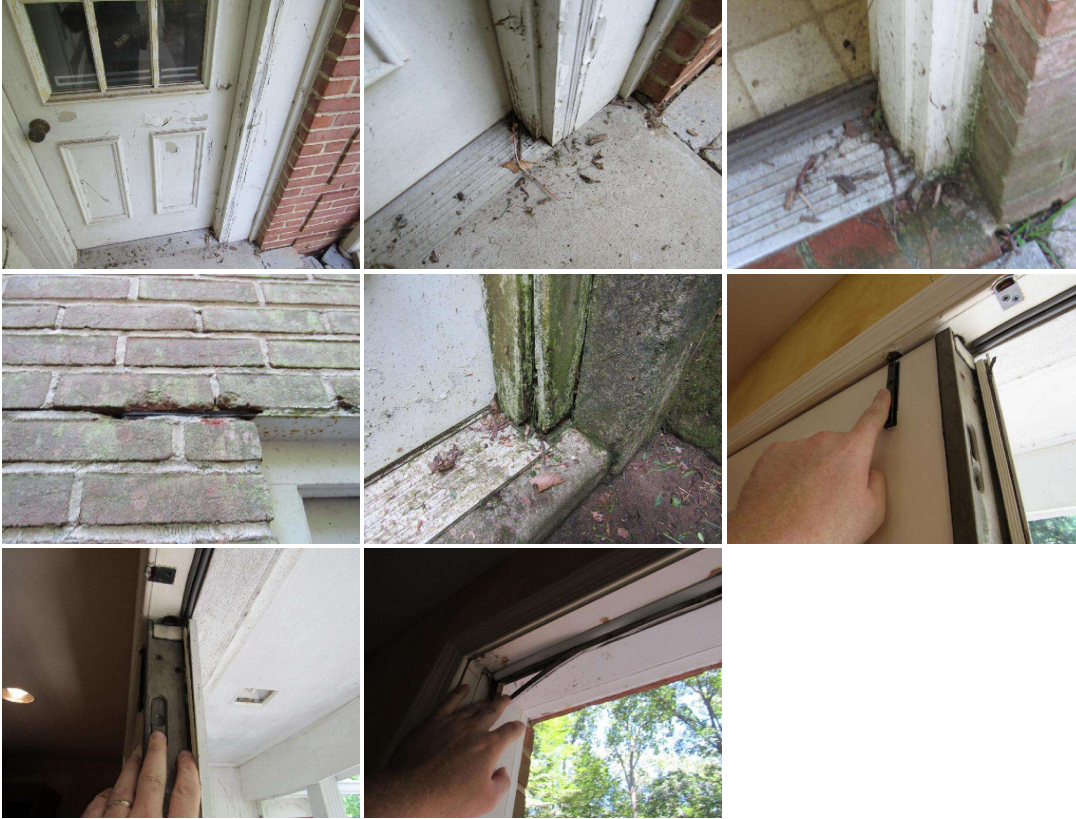
Entry Doors: (continued)

Defective Entry Doors: Metal - Basement door has wood rot at base of casing. laundry door has a failed seal. breezeway door is not locking correctly. several door have paint peeling. Have doors repaired by qualified contractor.

4. Entry Doors: Metal - Basement door has wood rot at base of casing. laundry door has a failed seal. breezeway door is not locking correctly. several door have paint peeling. Have doors repaired by qualified contractor.

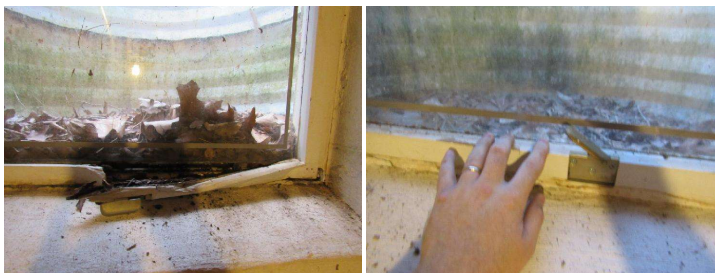
Basement Windows: basement windows are rotted and should be replaced by a qualified contractor.

6. Basement Windows: basement windows are rotted and should be replaced by a qualified contractor.

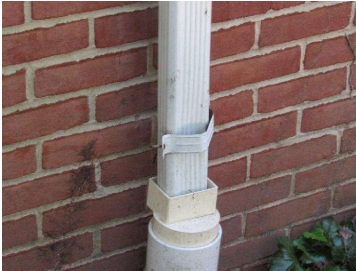
Marginal Gutters: Aluminum - Need cleaning

Marginal Downspouts/Leader: Aluminum - Loose or missing clamps

6. Gutters: Aluminum - Need cleaning
7. Downspouts/Leader: Aluminum - Loose or missing clamps

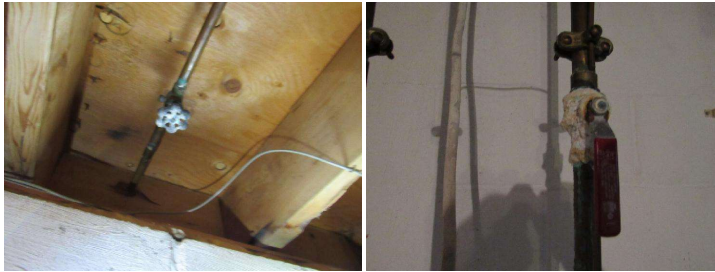
Water Lines: (continued)

Marginal Water Lines: CPVC and copper - Water was turned off at the property at the time of inspection. Many shutoff valves show significant corrosion. Hose bib shut off, water heater, and washer hookups all showed deterioration. Suggest having water turned on by a professional and all shutoff valves checked and replaced as needed with ball valves. Recommend replacing them all preemptively.

8. Water Lines: CPVC and copper - Water was turned off at the property at the time of inspection. Many shutoff valves show significant corrosion. Hose bib shut off, water heater, and washer hookups all showed deterioration. Suggest having water turned on by a professional and all shutoff valves checked and replaced as needed with ball valves. Recommend replacing them all preemptively.

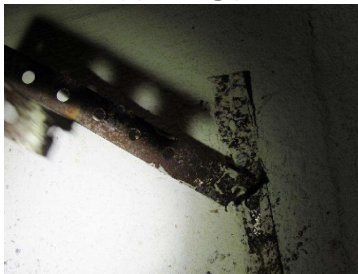
Drain Pipes: Cast iron/ galvanized, PVC - The visible portions of the drain pipes include an older cast-iron type, which are not as dependable as modern PVC drainpipes. They cannot be expected to last forever. In general, it has been said that cast iron drainpipes have a life span of around 50 years. Suggest having the sewage line scoped by a qualified contractor to inspect for damage and repair as needed.

- strap supporting pvc has rusted and broken; have repaired by a qualified contractor.

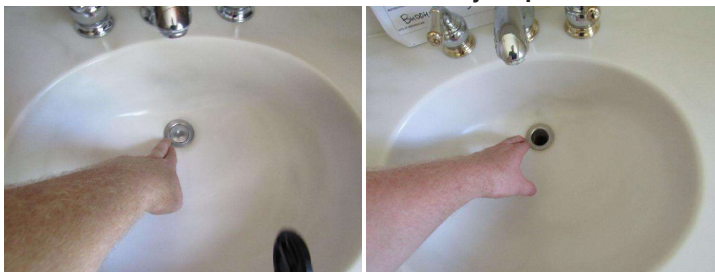
Bathroom Sink/Basin: several stoppers do not work or are missing. Once water is turned on have further evaluated and corrected as needed by a qualified contractor.

9. Bathroom Sink/Basin: several stoppers do not work or are missing. Once water is turned on have further evaluated and corrected as needed by a qualified contractor.

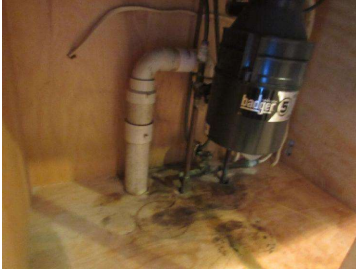
Marginal **Faucets/Traps: "S" Type drain traps do not meet today's standards, one is present in the kitchen.**

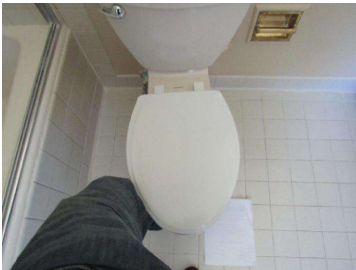
Defective **Toilets: The toilet in the master bathroom is loose at the floor and will require replacement of the wax seal.**

7. Toilets: The toilet in the master bathroom is loose at the floor and will require replacement of the wax seal.

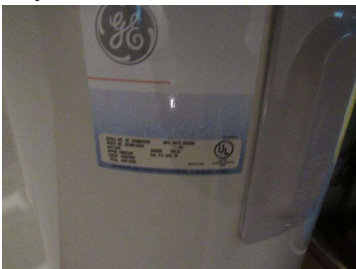
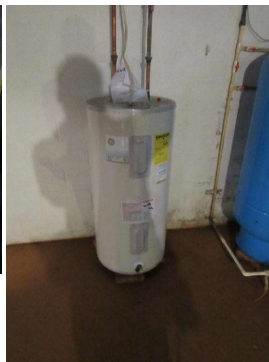
Marginal **Water Heater Operation: Did not function at time of inspection - water turned off to house. Water heater has exceeded design life expect to replace in the near future. TPR valve is not correct, have repaired by a qualified contractor.**

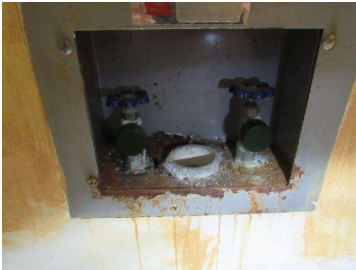
Marginal Washer Hose Bib: Inoperative at time of inspection, A licensed plumber is recommended to evaluate and estimate repairs

12. Basement Stairwell Drain: Surface drain - area very dirty, suggest cleaning and ensuring drain is functioning correctly.
13. Washer Hose Bib: Inoperative at time of inspection, A licensed plumber is recommended to evaluate and estimate repairs

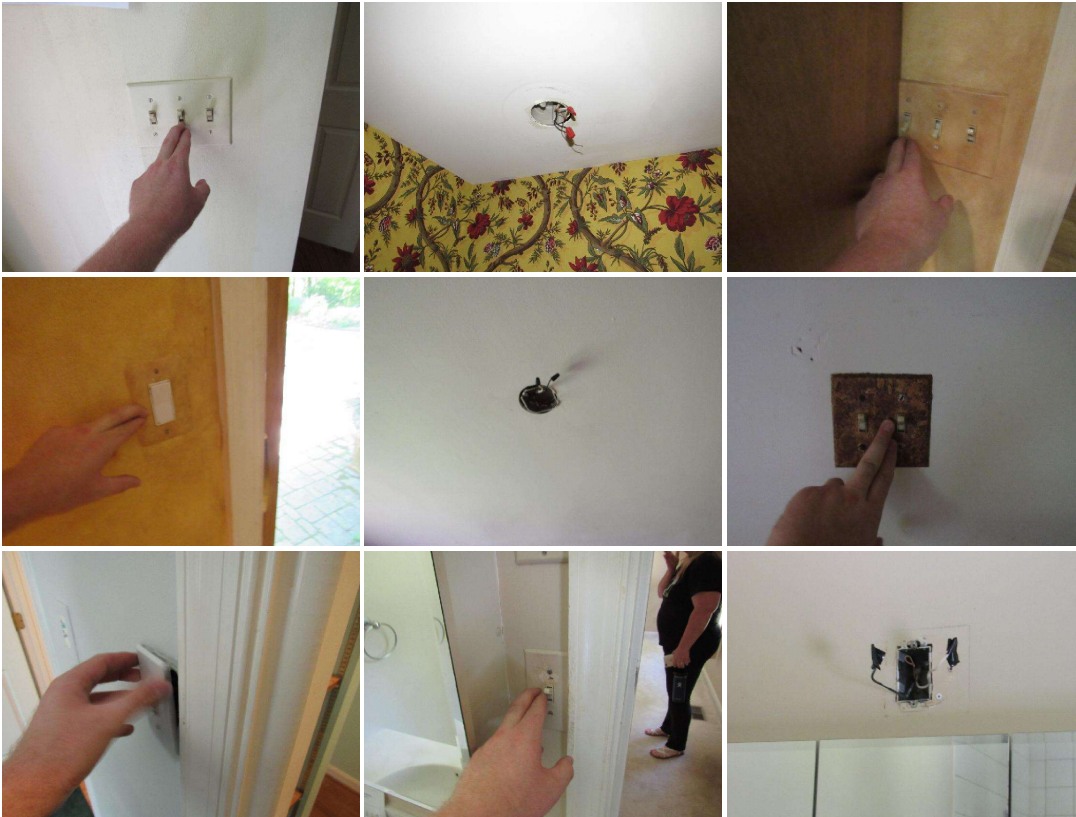
Defective Interior Lighting: 110 VAC - Missing several fixtures. Some lights did not work, some switches did not appear to do anything. Have further evaluated and repaired by a qualified contractor.

8. Interior Lighting: 110 VAC - Missing several fixtures. Some lights did not work, some switches did not appear to do anything. Have further evaluated and repaired by a qualified contractor.

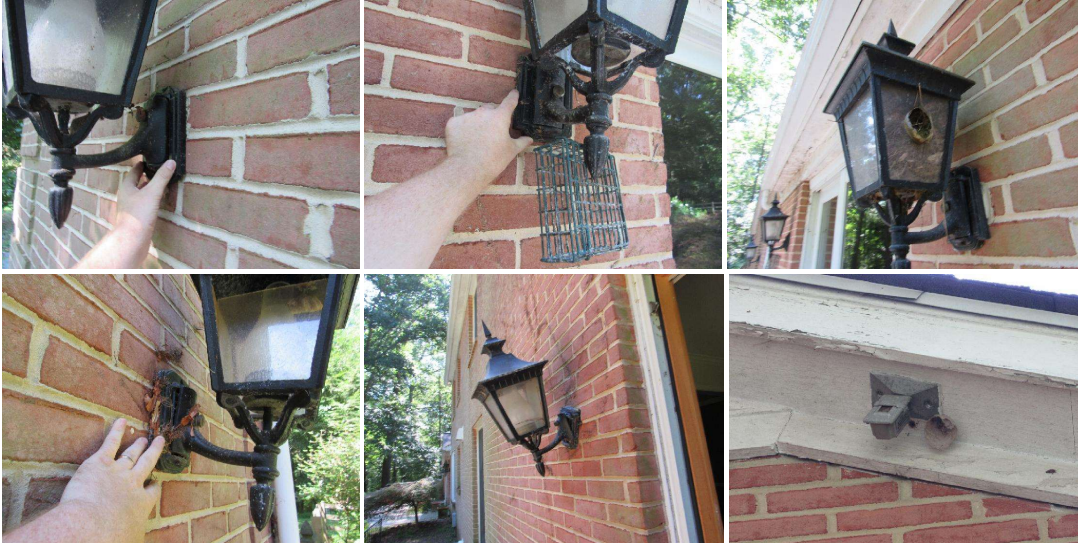
Exterior Lighting: (continued)

Defective Exterior Lighting: Surface mount - We do not inspect all of the spot lights and decorative garden lights. Some may be on timers. Or switches. Recommend asking the seller to demonstrate how well they work. Any low-voltage or garden lights installed would not be permanent and may not stay with the house.

- many sconces are failing or damaged, have replaced or repaired as needed by a qualified contractor.
- broken floodlight.

- many sconces are failing or damaged, have replaced or repaired as needed by a qualified contractor.
-broken floodlight.

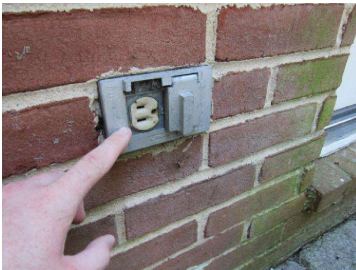
Defective Exterior Electric Outlets: 110 VAC GFCI - missing cover plate. Have replaced by qualified contractor,

13. Exterior Electric Outlets: 110 VAC GFCI - missing cover plate. Have replaced by qualified contractor,

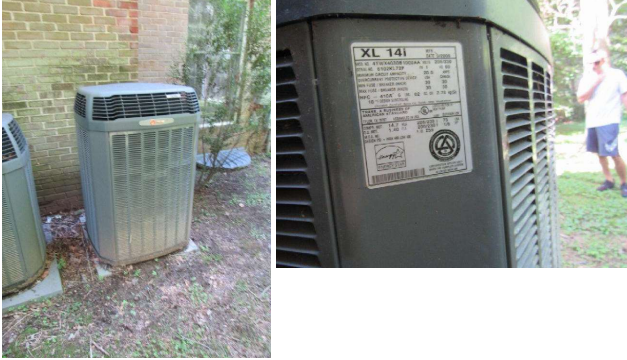
Defective A/C System Operation: Inoperative - A qualified air conditioning contractor is recommended to evaluate and estimate repairs.

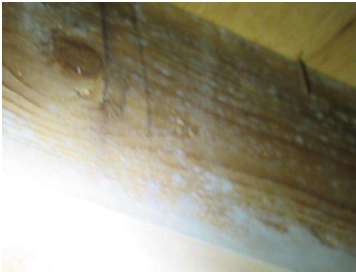
Defective Ceiling: Exposed framing - Framing had suspected organic growth on several joists. Look to the EPA for guidelines on remediation or hire a professional.

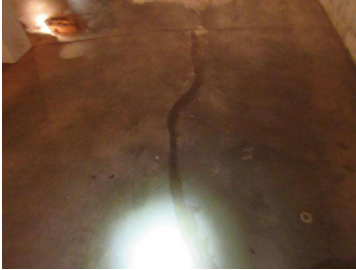
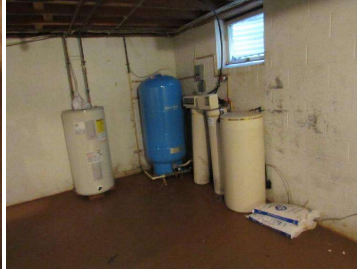
water present: (continued)

Defective water present: Slab - A significant amount of water was present in the basement. It is my suggestion that the basement stair drain area be cleaned and checked to ensure it is draining. All downspouts be checked to ensure they are draining. walking around the exterior after a heavy rain to ensure no water is sitting against the foundation and grading be corrected as needed. monitor the basement during and after a heavy rain to isolate trouble areas. Re-caulk perimeter of basement. Ensure the dehumidifier is running consistently. If water persists it is likely a ground water problem and a French drain may need to be installed; consult with a qualified professional for estimates.

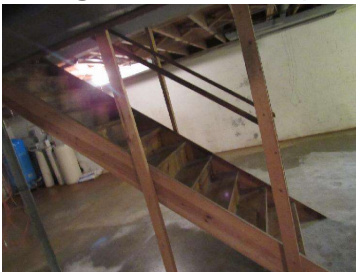
Marginal Railings: wood - no fall protection present.

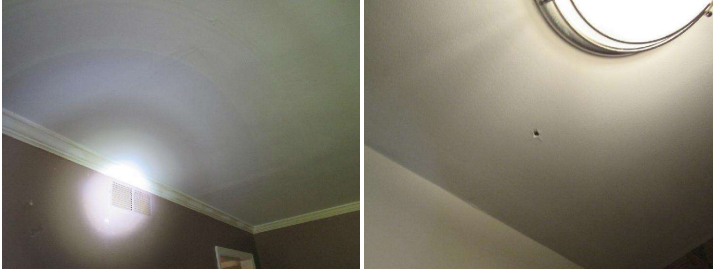
Ceilings: (continued)

Acceptable Ceilings: poor patch installation under 2nd floor bathroom, water stain in foyer. monitor once the water has been turned on to ensure these are not active leaks. No moisture detected at the time of inspection. nail pops observed.

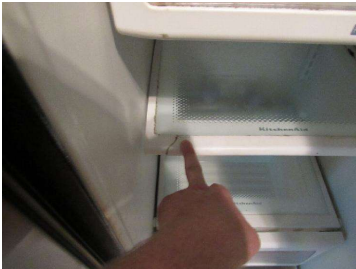
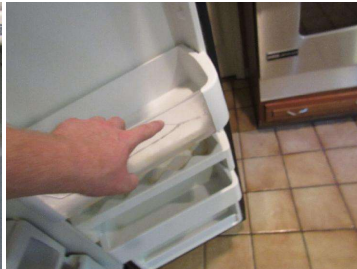
Marginal Refrigerator: broken shelves present.

- 22. Refrigerator: broken shelves present.

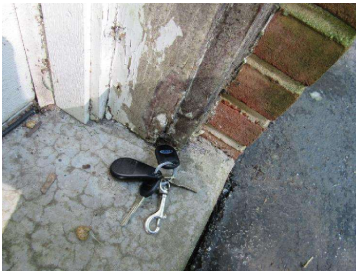
Marginal Garage Doors: Metal - wood rot noted at base of casing. Could not operate door as it was locked shut. Have door unlocked and ensure it is operational.

- 23. Garage Doors: Metal - wood rot noted at base of casing. Could not operate door as it was locked shut. Have door unlocked and ensure it is operational.

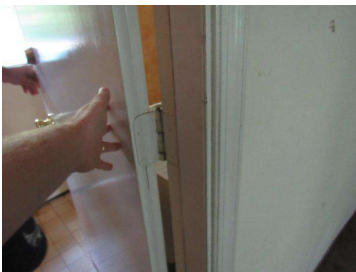
Defective Service Doors: all doors to interior from garage should be self closing. Have corrected by a qualified contractor.
